# Spear Road Ravine Design/Build Report

Whitley County, Indiana

September 28, 2004

## **SPEAR ROAD RAVINE DESIGN/BUILD REPORT EXECUTIVE SUMMARY**

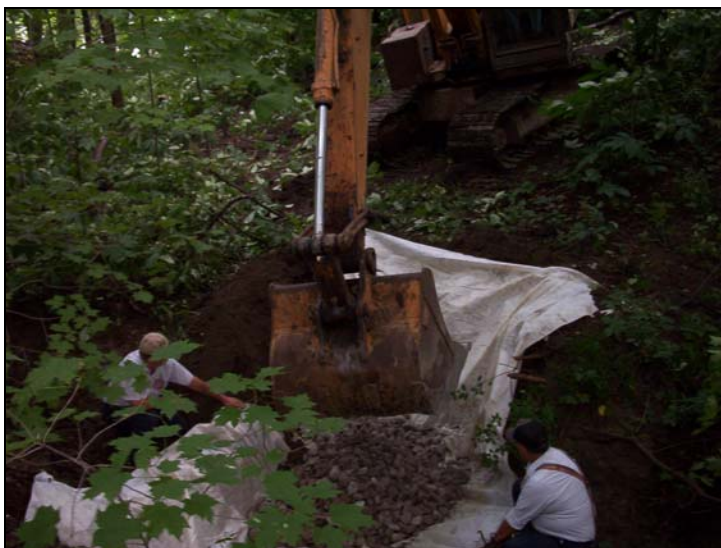
**Figure 2. Typical non-woven geotextile erosion control blanket placement.**

A series of three check dams was installed within the small ravine. Check dams were constructed by excavating a key trench three feet into each storm flow channel bank and two feet into the channel bed. The bottom and sides of each key trench were then lined with a non-woven geotextile fabric (Figure 2). The key trench was then filled with fieldstone to the appropriate elevation according to the plans. Fieldstone, measuring at least six inches in diameter, was graded to a 3:1 slope on both the upstream and downstream face (Figure 3). Site plans, stream cross-sections, and check dam details can be found in can be found in Appendix A.

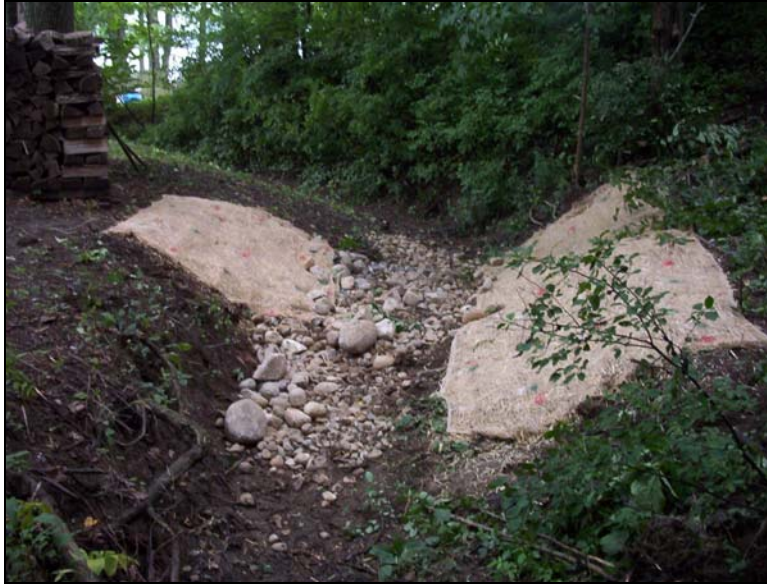
**Figure 3. Typical erosion control blanket placement and check dam.**

Ravine slopes disturbed by check dam construction were seeded with Virginia wild rye (*Elymus virginicus*) and then covered with a biodegradable erosion control blanket (North American Green SC-150 BN). The erosion control blanket was secured with 6-inch metal sod staples on 1.5 foot centers. Figure 3 shows typical erosion control blanket placement within the ravine.

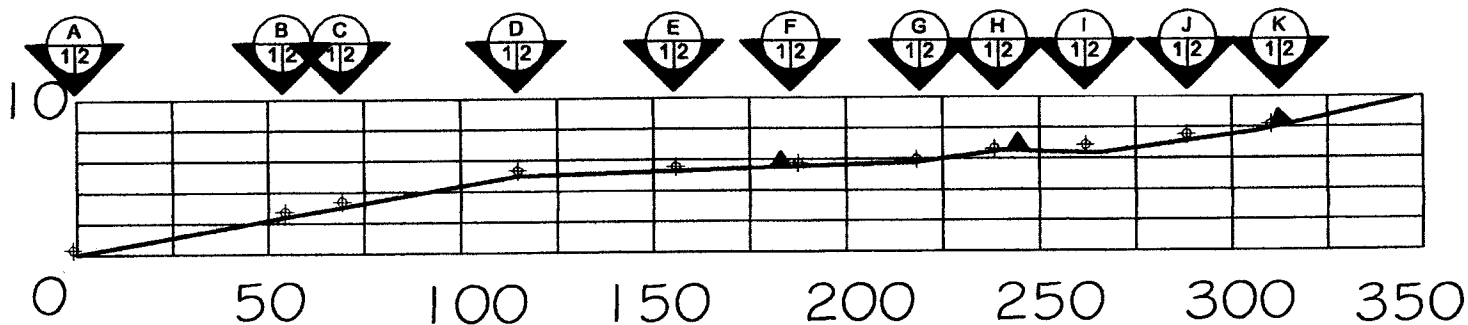
SCALE: 1" = 50'  
DATE: 7/29/04  
FILE: 94-01-12  
PROPOSED SITE PLAN

The design and placement of the check dams also had to account for the potential of landowner flooding. For this reason, the check dams were placed in the upstream reach of the ravine near Stations F, H, and K and incorporated low peak elevations. Each check dam is no higher than 1.5 feet above the existing storm flow channel bottom elevation (Appendix A).

# PLAN VIEW

# PROFILE VIEW

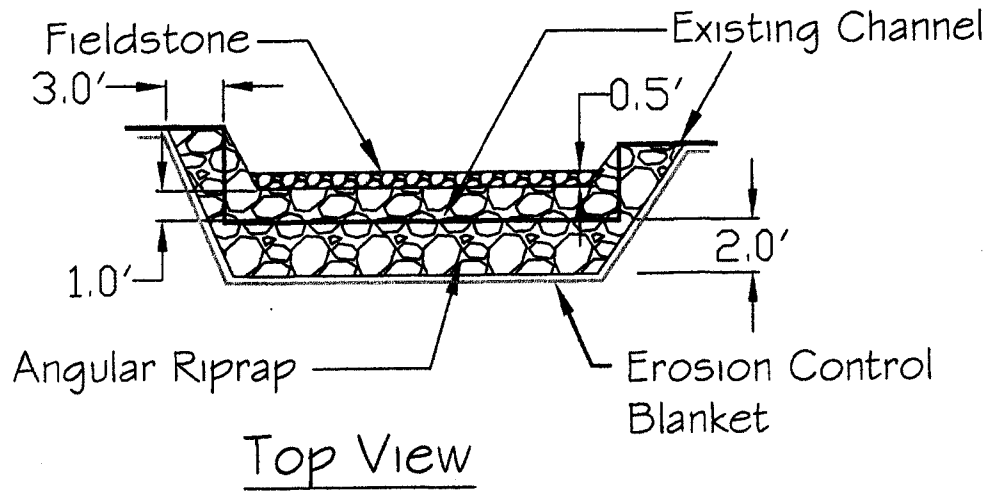
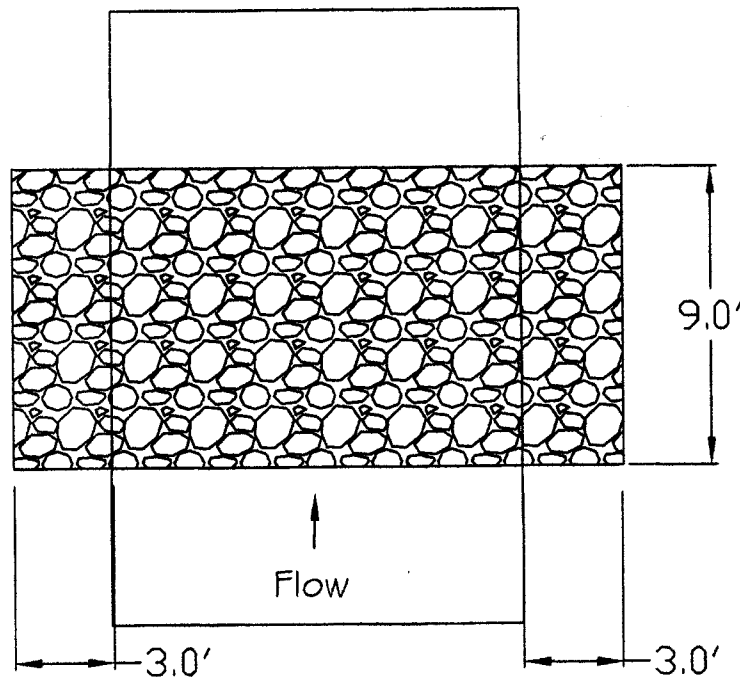
Typical Check Dam Design

1. Angular riprap will be keyed 3' into each bank and 2' into the bed.
2. Fieldstone used for the cap will have a minimum diameter of 6".
3. The final slope of the upstream and downstream faces will be 3:1.
4. Erosion control blanket shall be placed in the bottom of the key trench prior to riprap placement.
